DATE:	July 15, 2011
FROM:	Steve Stumne
SUBJECT:	Wetland Reconnaissance – Boardman River
TO:	MACTEC Project File Number: 3310110004

Title: Boardman River Wetland Reconnaissance—June 22 and 23, 2011

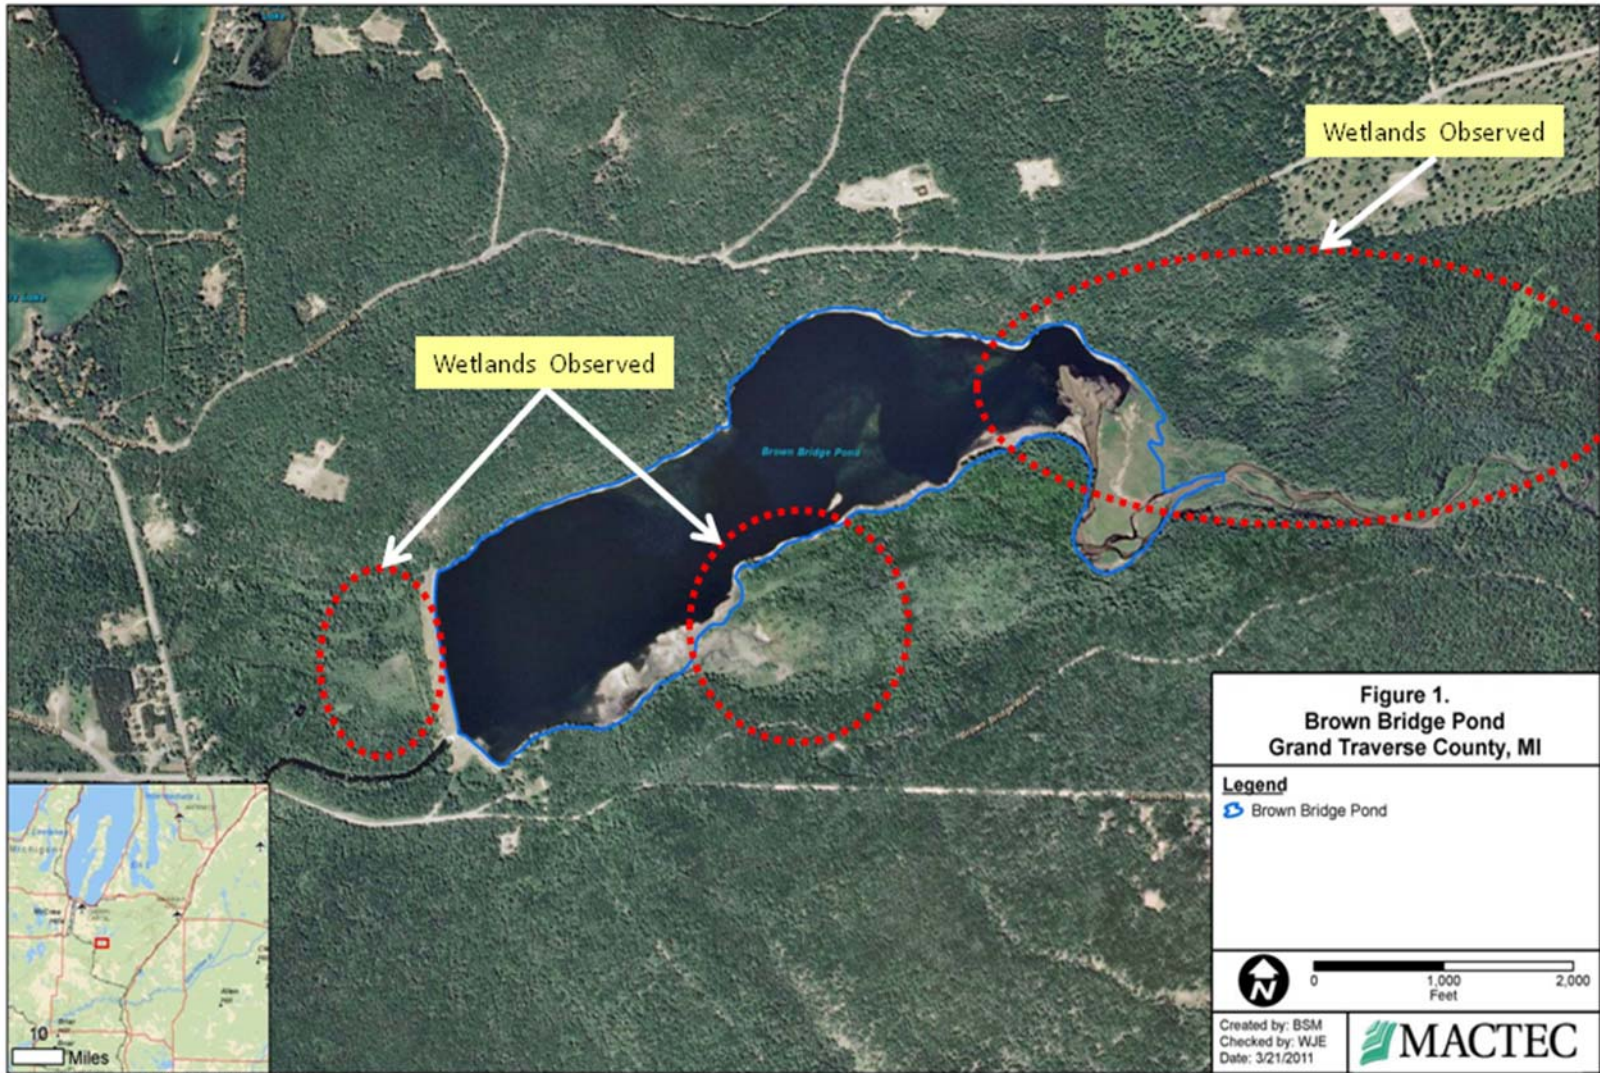
A reconnaissance level field investigation of wetlands within the vicinity of Brown Bridge and Sabin Ponds (Figures 1 and 2, respectively) was conducted to provide additional insights to wetland characteristics (vegetation, hydrology, soils) of the project area. Key elements of the reconnaissance effort were focused on evaluating wetlands in the immediate vicinity of the ponds and potential mechanisms for environmental impact (losses and gains) associated with dam removal and ecosystem restoration initiatives and in understanding the accuracy and sufficiency of the prior mapping effort done as part of the Feasibility Study (FS) prepared by Environmental Consulting & Technology, Inc. (ECT) which included a wetland determination which are referenced below as wetlands A, B, etc. Incidental observations of wildlife and invasive species were also made at each site to supplement characterizations of the local environmental conditions as part of the National Environmental Policy Act (NEPA) process.

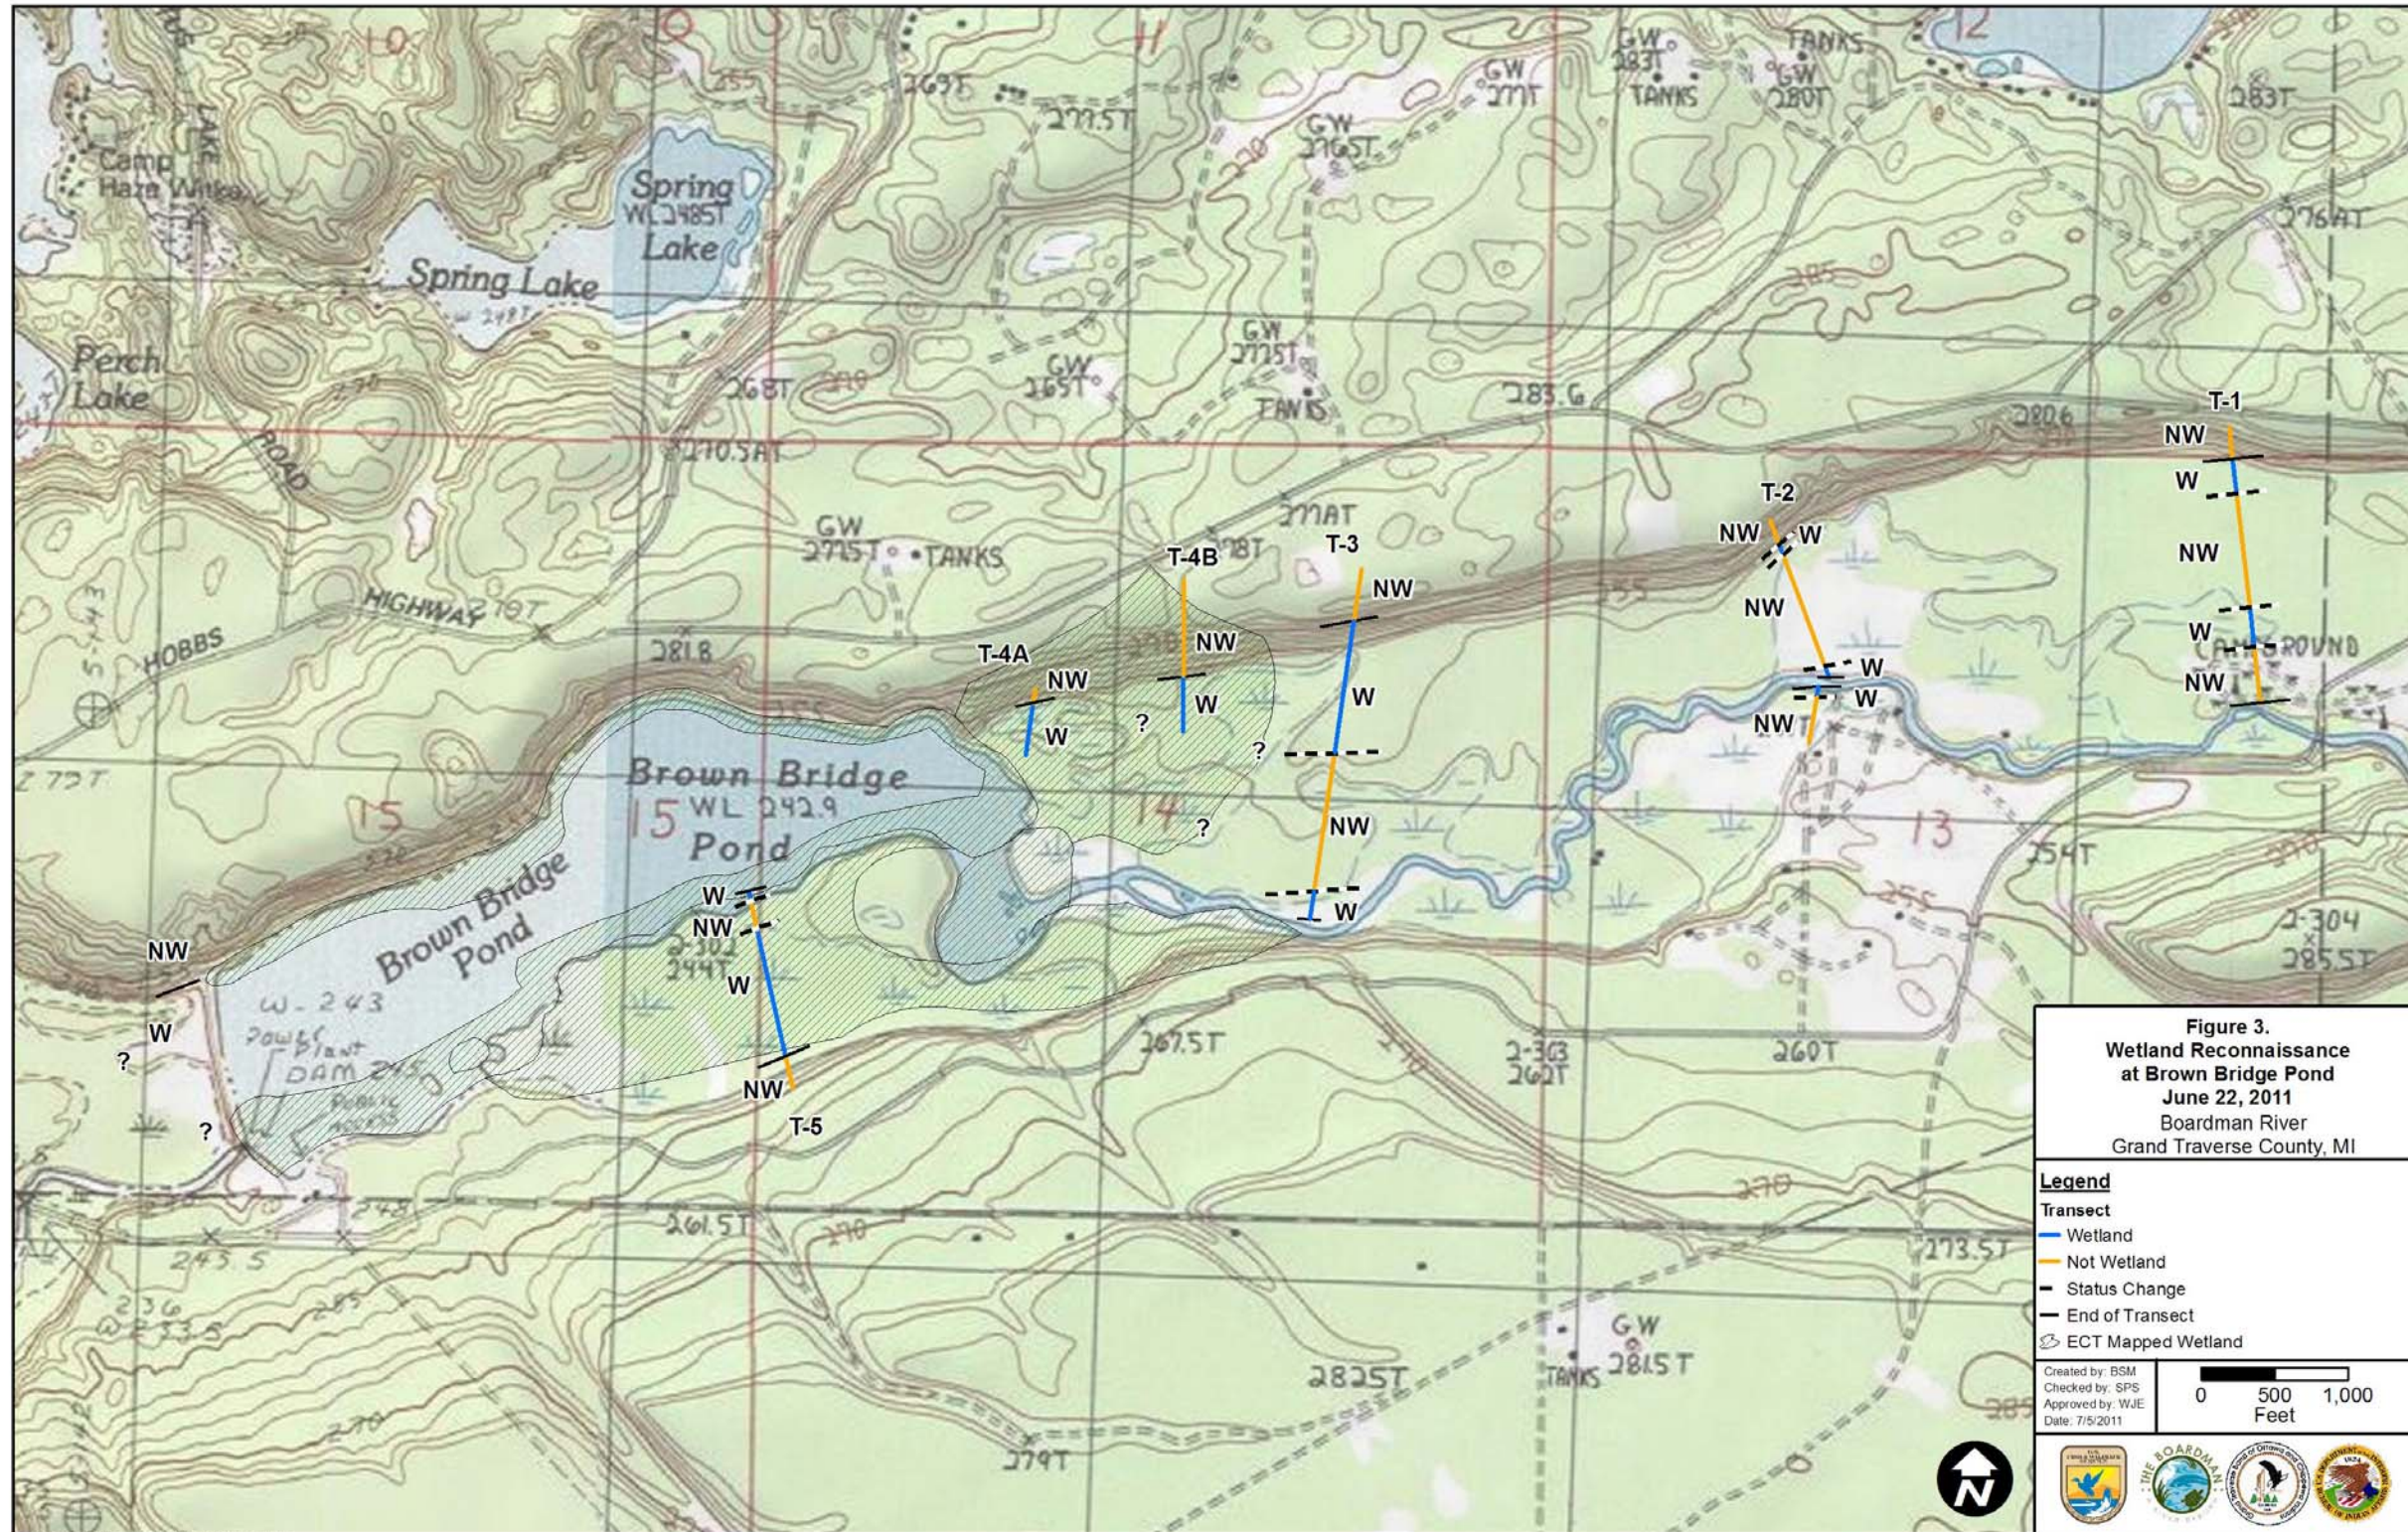
- b) Launched canoes from Scheck’s Campground.
- c) A total of five transects were walked (generally oriented north-south) at locations identified Figure 3. Global Positioning System (GPS) points were recorded at locations along the transects indicating where the plant community appeared to change from wetland to upland and vice versa. Transects were walked from the river bank to the toe of the valley walls.

- d) Wetlands that exist in the valley above the influence of Brown Bridge Pond appear to have a hydroperiod that is primarily groundwater-fed.
- e) Transect 4 was a “disjunct” transect located through a portion of ECT Wetland A. This effort confirmed that the current boundary of Wetland A is incorrect. The wetland does not extend up the valley slope and the draw or ravine on top of the slope is an upland community. Uncertainty exists about the location of the boundary in this area.

- f) Transect 5 was located through the middle of ECT Wetland B. A narrow strip of upland separates emergent from forested wetland communities. Most of this transect was located in a wetland. However, uncertainty exists about the location of the boundary of this wetland.
